RJMC Retrieve on EVA 3

- The ISS Program has asked you to retrieve the S1 Zenith RPCM and bring it home
 - This RJMC failed much sooner than expected and troubleshooting is highly desired prior to the launch of spares and the 4 integrated RJMCs on flights 12A & 13A

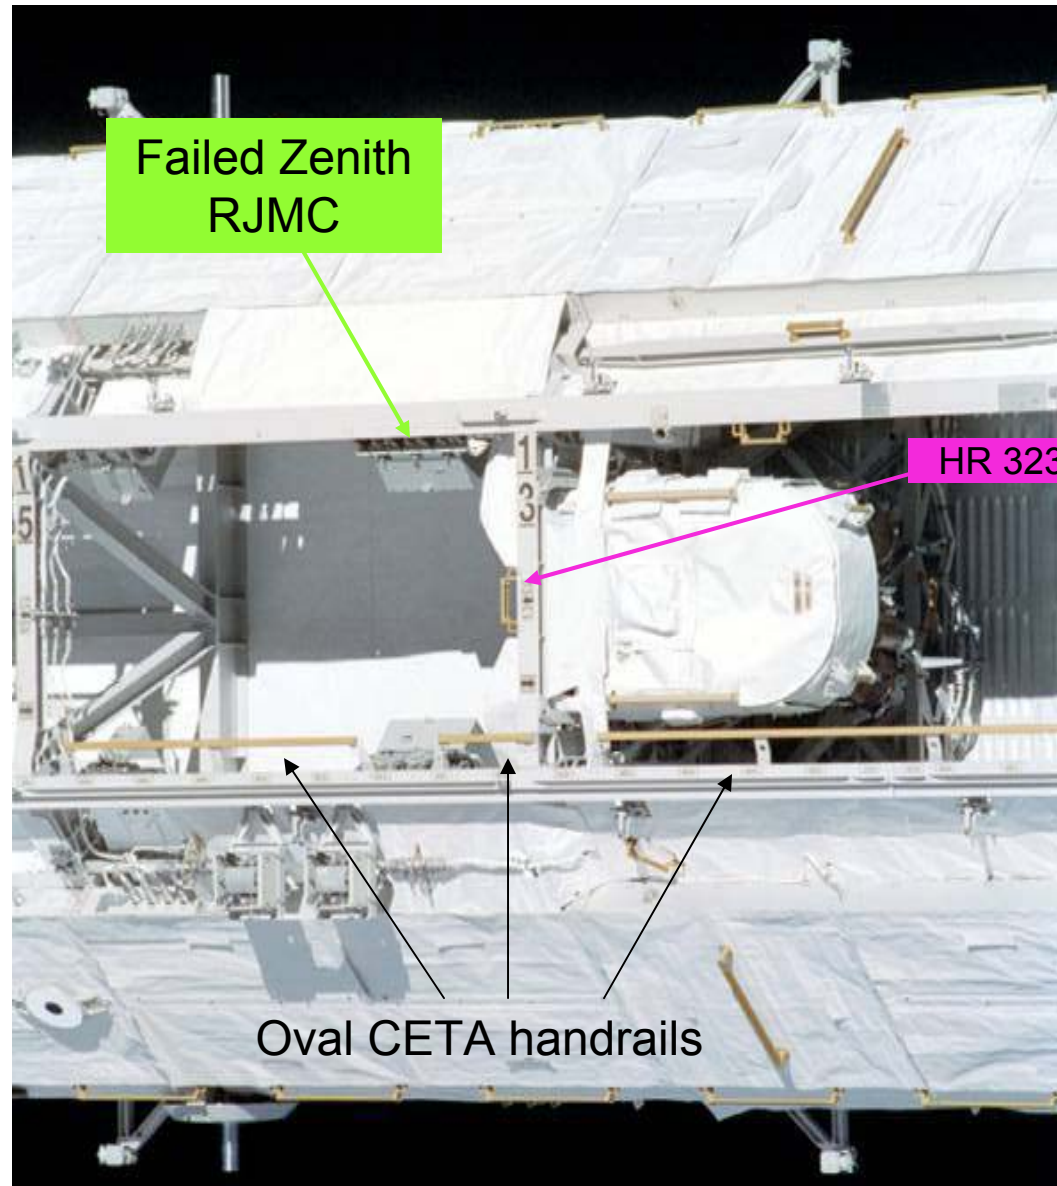
S1 Bay 13 Overview

- The failed RJMC is in S1 Bay 13, adjacent to the Zenith rail and accessible thru Face 1
- The RJMC is a typical “6B box” with 3 bolts (like the dummy box)

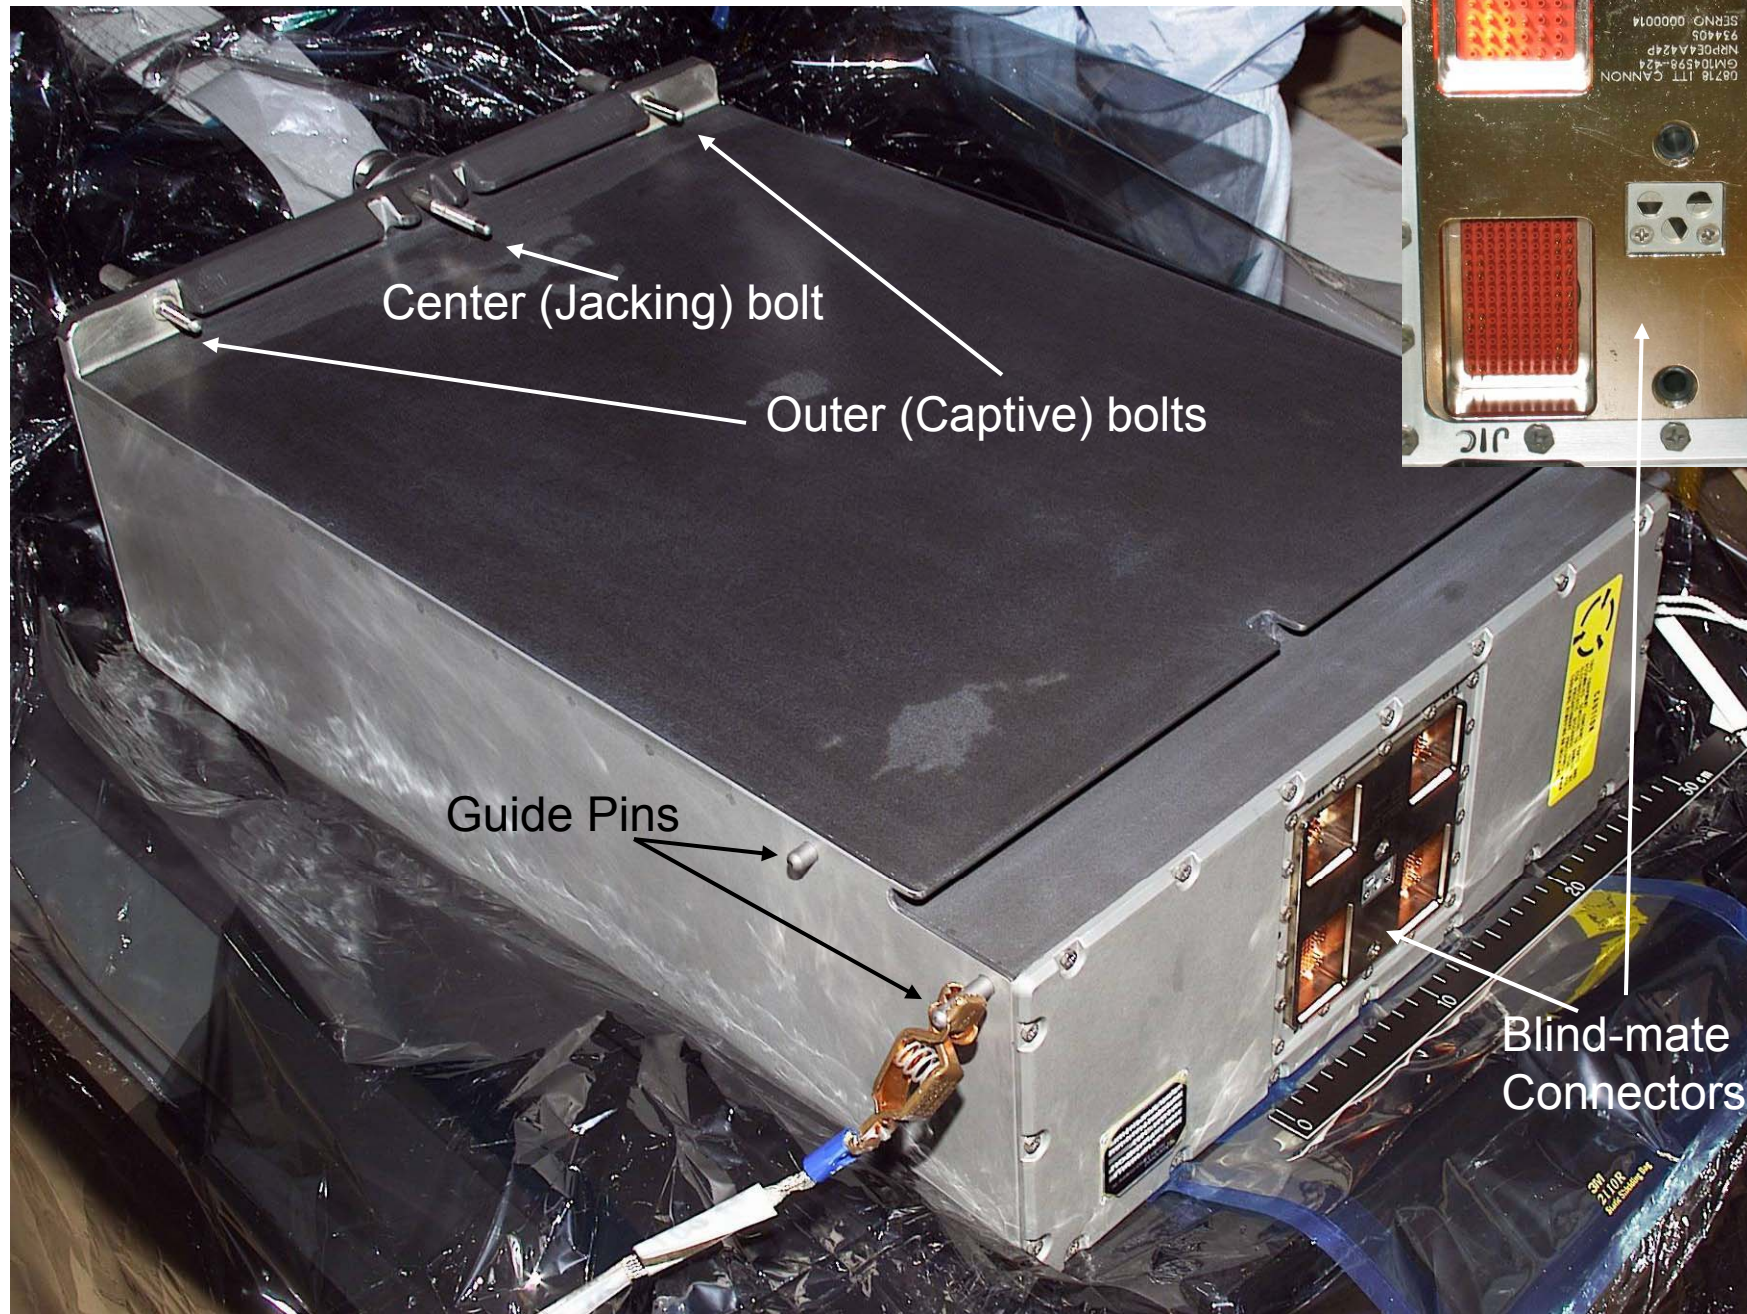
RJMC (upside down)

- There are no fins or other sensitive material (e.g. cotherm or thermal paint) on the exterior of the box
- There are 4 blind-mate connectors on the back of the box. The pins are on the RJMC side, but are recessed

Blind-mate
connector
(sockets)

- A center “jack bolt” within the micro-conical is used to draw the RJMC in and engage the blind mate connectors during installation and the reverse for removal

- Two outer “captive fasteners” provide additional on-orbit restraint; these bolts must be completely released prior to driving the center jacking bolt
